# Post-seismic Effectiveness of the Strengthening Work Carried Out with GFRP Applied to Historical Masonry Buildings: The Case Study of the Spoleto Cathedral

Alessandro Grazzini<sup>1 (\*)</sup>, Stefano Agnetti<sup>2</sup>

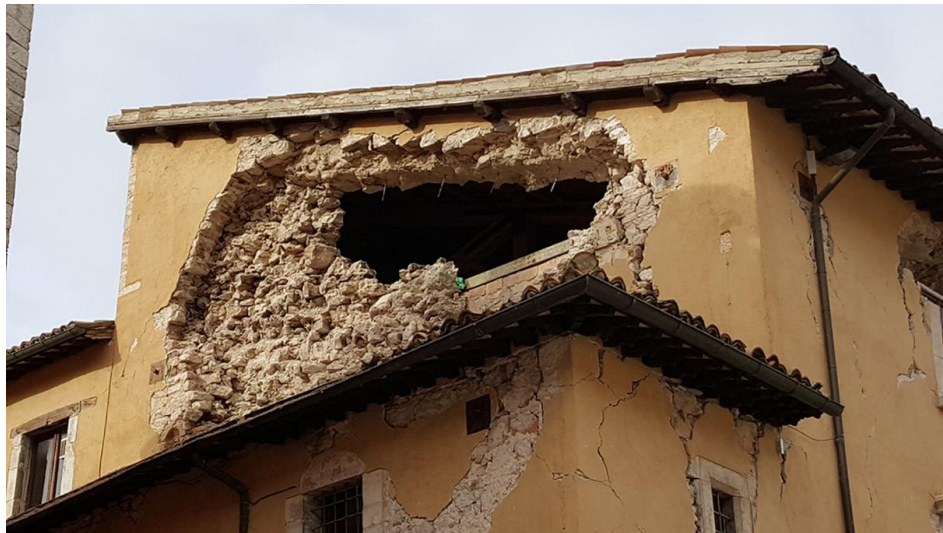
tral Italy highlighted the vulnerabilities present on the historical buildings, and the ineffectiveness of some strengthening techniques that proved useless to protect the buildings during the subsequent earthquakes<sup>[1]</sup>. Masonry cracks opened in previous earthquakes and simply sewn by cement injections, reopened and re-exposed the same vulnerabilities during the last 2016 Amatrice-Norcia earthquake (**Figure 2**). In some cases even the buildings strengthened by reinforced cement plasters not connected transversely collapsed to the next powerful earthquake. Seismic damage often regards out of plane mechanisms of the multi-leaf and not effectively connected masonry walls (**Figure 3**).

**Figure 3.** Out of plane collapse of a multi-leaf masonry wall (2016 Amatrice-Norcia earthquake).

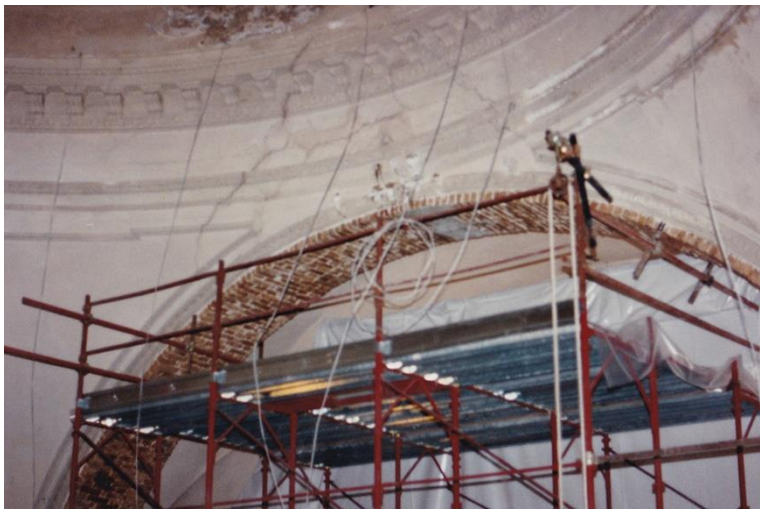
After the 1997 Umbria-Marche earthquake, the Spoleto Cathedral was subjected to a detailed survey carried out in order to know the actual conditions of the monument about the structural and security aspects. The non-homogeneous distribution of the damages present in the various parts of the cathedral showed a different behaviour towards the seismic actions. So the seismic events have highlighted the structural weaknesses, also amplified by the absence of maintenance. The façade showed widespread degradation, mainly due to water infiltration. The main aisle instead suffered cracks on the barrel vault following the seismic action. In the left aisle there were diagonal cracks with respect to the axis of the church in correspondence with the cross-vault centreline. In the area of the high altar there were instead cracks in correspondence of the triumphal arch near the apse (**Figure 8**). In this arc there were produced deep cracks and tilted both in key and in the kidneys which produced a detachment of the central part of the arch up to the dome's turn. In the left transept there was a detachment between the barrel vault and the stiffening arches. The most serious damage occurred in the Chapel

**Figure 8.** The cracks of the triumphal arch of the main nave.

All strengthening materials were supplied by Kimia S.p.A.<sup>[6]</sup>. The barrel-vaulted cracks were stitched by means of fiberglass composite material (GFRP) to repair the existing cracks (**Figure 9**). In addition tie rods was put at the level of the top curb to prevent the out of plane phenomena (**Figure 10**). On the dome and on the lantern, strengthening works were carried out by means of injections (**Figure 11**) and reinforcement circle building.

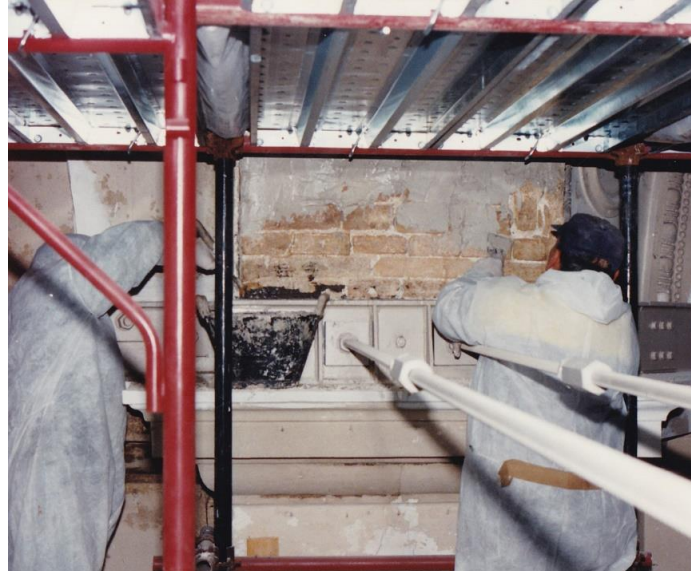
**Figure 10.** Strengthening work near the insertion of tie rods.

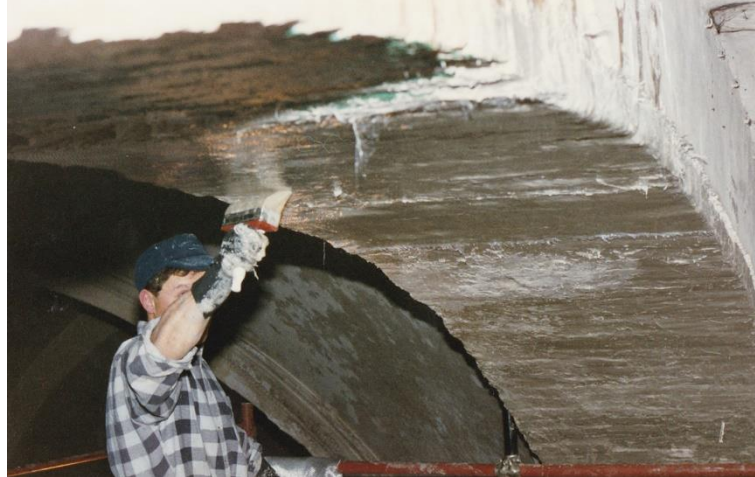
**Figure 12.** Application on the treated surface of two-component synthetic resin primer in aqueous dispersion.

primer. First of all, application on the treated surface of two-component synthetic resin primer in aqueous dispersion (**Figure 12**). Subsequent application of solvent-free two-component thixotropic epoxy adhesive (**Figure 13**).

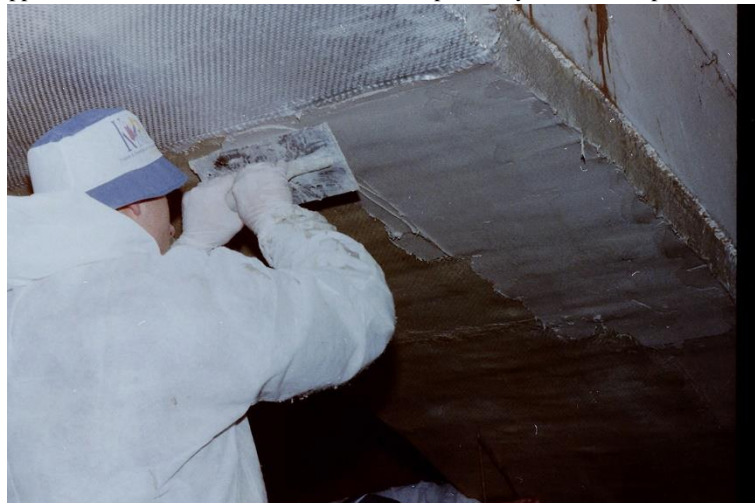
**Figure 13.** Application of solvent-free two-component thixotropic epoxy adhesive.

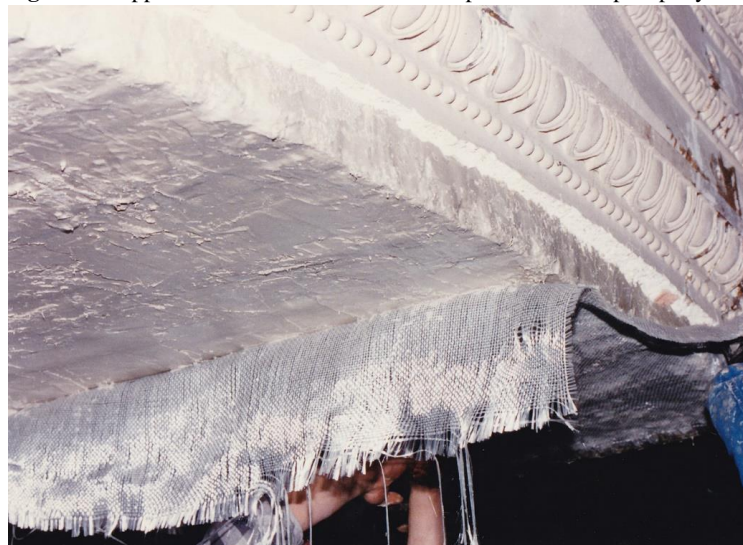
**Figure 14.** Intrados application of GFRP band for strengthening arch.

The product had the function of levelling the surface to be reinforced and creating an adhesive layer for the subsequent application of the reinforcement. The application of the fabric occurred in the fresh air, applying fibre bands with an iron roller and exert a slight pressure, taking care not to create air bubbles (**Figure 14**). The fabric was pressed in the resin layer, using the roll for composites (always roll in the direction of the fibers, exerting slight pressure paying attention not to move the fabric during this phase). It was necessary to roll until the resin emerges between the fibers and impregnates them completely, forming a uniform layer on the fabric. It was very important to remove any air bubbles that may be trapped between the fabric and the substrate, continuing to roll in the direction of the fibers. Subsequent impregnation with solvent-free, two-component, fluid-containing epoxy resin applied by brush or roller in several coats and slowly so that the impregnation of the fabric was complete. Any further reinforcement layers should be applied fresh on fresh and immediately impregnated with resin.

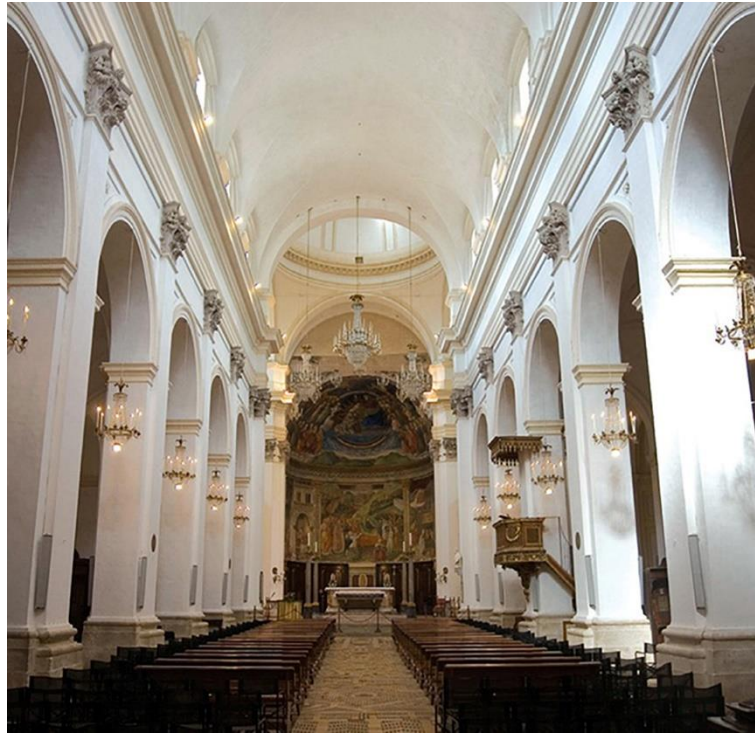
Thanks to this series of structural reinforced work, during the 2016 Amatrice-Norcia earthquake the Spoleto Cathedral has not suffered any damage confirming the seismic improvement achieved (**Figure 15**).

**Figure 15.** The interior of the Cathedral today after the safety work and after the 2016 Amatrice-Norcia earthquake.

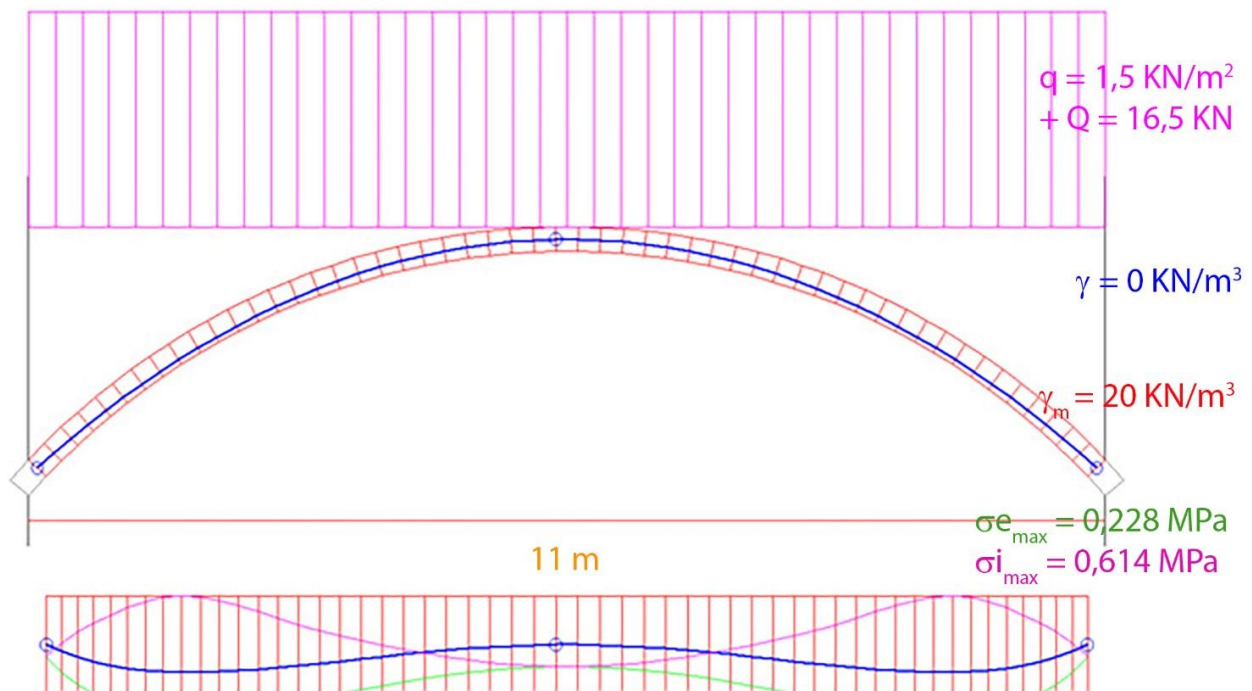
The analysis of the progress of the compression pressures on the vault of the Spoleto Cathedral (**Figure 16**) have been studied by tracing the behavior of the vault to that of an arch with a thickness equal to 25 cm and unit width of 1 meter. The span of the vault was 11 meters and the arrow was 2,5 meters. The mechanical characteristics of the masonry were as follows from the

Circolare 09/02/2009<sup>[9]</sup>, divided by the confidence coefficient 1,35 relative to a limited level of knowledge of the structure, as suggest by the Italian Technical Codes:

$$f_d = 2,40/1,35 = 1,78 \text{ MPa}$$

$$\tau_{0d} = 0,06/1,35 = 0,04 \text{ MPa}$$

**Figure 16.** Pre-strengthening analysis of the masonry vault in Spoleto Cathedral.

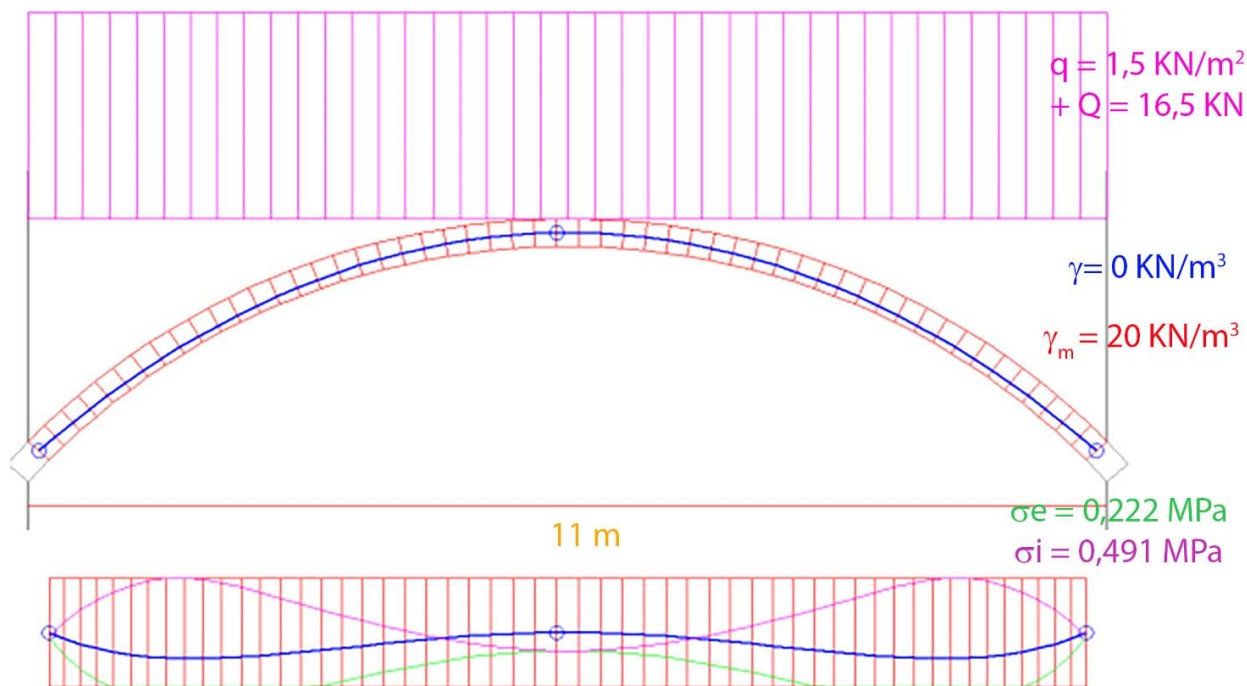
In the case of the reinforced vault, it can be seen that the center of the pressures tended to be more internal to the section and therefore the stresses were more reduced (**Figure 17**).

**Figure 17.** Strengthening analysis of the reinforced masonry vault in Spoleto Cathedral.
