Evaluation of Residual Strength of RC Columns in Fire-Damaged Buildings: Case Study

Abstract: Prediction of residual strength of structural members in a RC fire-damaged building is an important step in taking a decision about restoration or demolition of the building. In this paper a finite element model was developed to evaluate the distribution of temperature within the cross-section of a RC column during a fire. Then the results were used to estimate the residual strength of RC columns in a fire damaged building in Libya. The building was used as a court yard for the public and the fire visibly damaged some of its columns. Material tests were conducted in situ and in the laboratory in order to evaluate the material strength after fire. Finite element analysis results and Euro code formulations were used in the prediction of material properties during fire. The predicted properties shows good agreement with material test results. Furthermore analysis results shows that up to 60 min of fire duration the column do not lose considerable amount of its strength, however at 120 min fire duration it will lose about 35 percent of its axial load and moment carrying capacities.

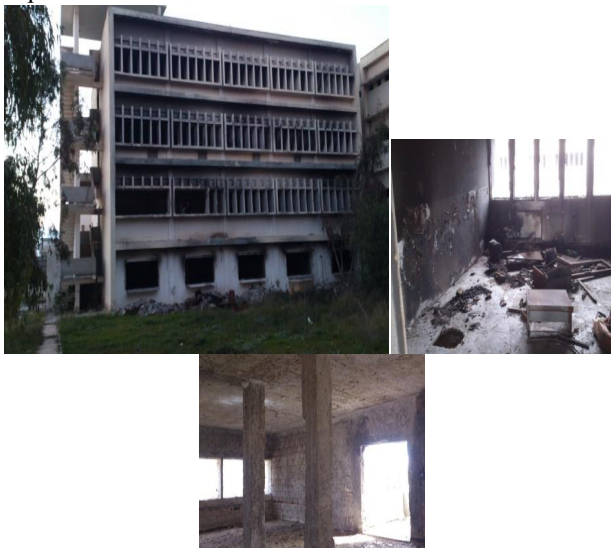
fire occurred in the right wing of the ground floor of the building, and as reported by witnesses it lasted approximately for an equivalent continuous time 2 to 3 hours, involving a lot of paper documents, furniture and other materials. More reliable information about temperatures is obtained during on site surveys. All furniture, windows, doors, infrastructure are severely affected by fire. Most of the structural elements are grey to black in color. Examinations of rubble show all floor tiles are dismantled and burned, window glass is shattered but not melted. The electric wires are burned however the copper in electric wires had not been softened. These observations indicate that the temperature is in the range of 400 to 600 °C^[6,7]. This is also assured by the grey to black color of the structural concrete elements surfaces. Concrete color provides a broad, general guide of temperatures^[8]. The fire caused

readily visible surface damage, as shown in **Figure 1**. The residual strength evaluation process used in this research involves calculating the distribution of temperature within the concrete cross-section, then calculating the axial load and the moment capacities of the member using residual strength versus temperature relationships suggested by Euro code. Furthermore material tests were conducted in situ and in the laboratory in order to evaluate the material strength of the RC members after fire and the results were compared with the Euro code relationships. The following sections show the details of building description, material tests, heat transfer analysis, and residual load carrying capacities calculations.

Figure 1; General view of the building after fire.

5. Depending on material test results, thermal analysis results and witnesses report it is clear that the building was exposed to fire up to 2 or 2.5 hours. And this will reduce the axial and moment capacities of the columns by more than 35%. Hence the building's columns need to be strengthened in order to be able to support future earthquake loads. Steel cages or RC jackets can be used for strengthening.

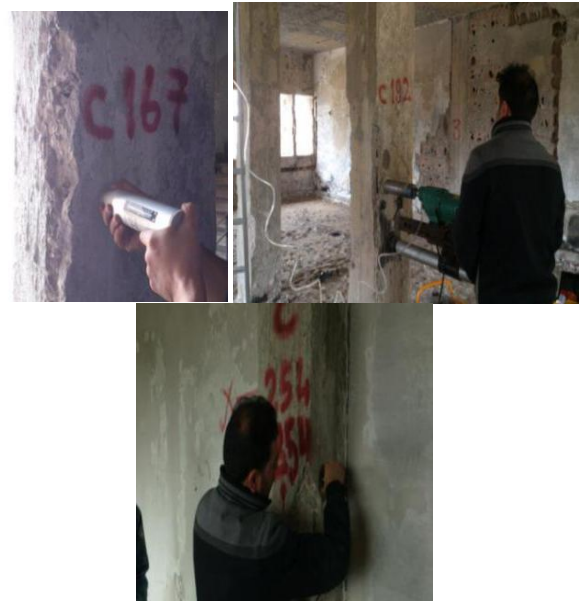
Tests were conducted in situ and in the laboratory in order to determine concrete material properties. The non destructive rebound hammer and pulse velocity tests were conducted in situ according to the recommendation given in ACI 228-R10 and ASTM C 805^[10]. In the rebound hammer test all affected structural members are divided into grids with designation numbers and labels then the hammer test is performed and the rebound number is recorded. An average of at least ten rebound readings are taken for one test, see **Figure (3c)**. In the pulse velocity test method the estimation of the compressive strength of concrete is based on measuring the time it takes for a pulse of vibration energy to travel through a concrete member. The tests were performed according to ASTM C 597 standard^[11]. Some test results are shown in **Table 1** and **Figure 3**. 20 core samples have been extracted from the different structural elements affected by fire. Locations of the concrete core samples are established based on results of non destructive tests and visual inspection of the structure. Strength of concrete cores taken from the structural

elements is determined in accordance with ASTM C 42^[12]. For core length-to-diameter ratios different than 2.0, the appropriate strength correction factors given in ASTM C 42 were applied^[12]. Two types of concrete cores are extracted, full core length diameter 70 mm, and smaller size of diameter 25 mm. The small size cores are used to depict the concrete strength along the structural member from the near surface to fire and the far surface to estimate the extent of fire damage to the cross section. The equivalent specified concrete strength is calculated according to ACI 562-12^[13]. Typical results are shown in **Table 2**. Test results shows that the average compressive strength of fire unaffected concrete is about 17 MPa. However the most fire affected structural element (i.e Column C007 of the ground floor) has an average compressive strength of 9.6 MPa. Furthermore tests on core samples taken from different depths of a fire affected column indicate that the concrete strength near the column surface is about 11.8 MPa , and at the center

Figure 3; Some photos during testing a) core sampling, b) ultra sonic test, c) rebound hammer.

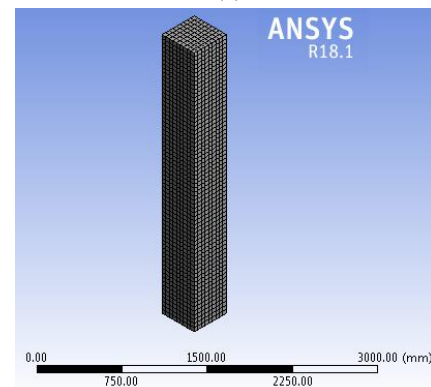
All the columns in the case study building have the same dimensions and steel reinforcement details as it is shown in **Figure 4 a**. During fire some of these columns were exposed to fire from four sides and the rest were exposed to fire from three or two sides. The finite element analysis program ANSYS was used to carry out a 3-D transient thermal analysis on one of the building's columns^[14]. The concrete column was modeled using an 8-node linear heat transfer brick elements as shown in Figure. 4b. Modeling of reinforcement bars was neglected and it is assumed that reinforcement bar temperature is equal to the surrounding concrete temperature. The developed FE model takes into account the nonlinear temperature dependant of concrete material properties such as specific heat, and thermal conductivity. The variation of concrete thermal conductivity with temperature specified by EN 1992-1-2:2004 code was used in the model (see **Figure 5**)^[4]. The concrete density is assumed to be constant and equal to 2300kg/m³. As a worst case the model was exposed to fire from four sides using ISO834 standard fire curve. From analysis results the distribution of temperature in the column section at different time intervals was obtained and presented in **Figure 6**. To illustrate the thermal predictions from the model, the temperature variation is plotted as a function of fire exposure time at various locations of the column cross section in **Figure 7**. The temperature at various depths of concrete, as well as in reinforcement bars locations, increases with fire exposure time. As expected, the predicted temperature decreases with increasing distance from the fire exposed side.

Figure 4; a) Column section details, b) FE model.

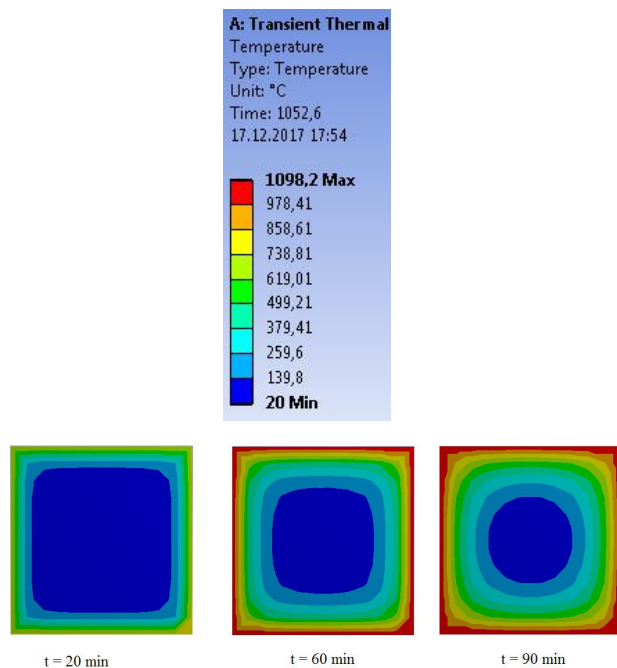
Figure 6; Temperature distribution.

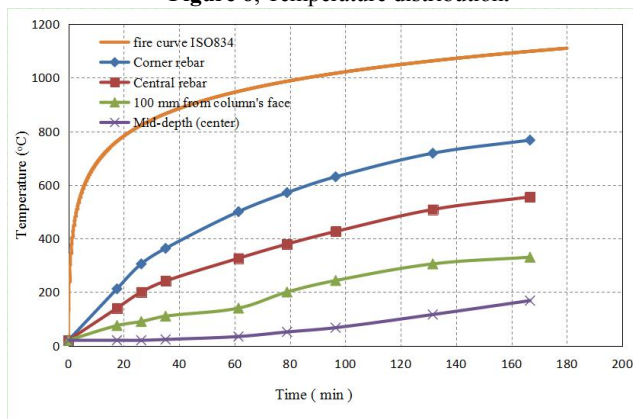
Figure 7; Temperature as a function of time at different locations of cross section.

1. From transient thermal analysis results shown in **Figure 7** it is clearly that the reinforcement bars at the column corners are more affected by fire than the central reinforcement bars. Furthermore at 60 min fire duration the average temperature of the reinforcement bars is about 400°C and according to Euro code this will reduce the elastic modulus of steel by about 30%.
2. At 120 min fire duration the average temperature of the reinforcement bars is about 550° C and

according to Euro code this will reduce the strength and elastic modulus of steel by about 32% and 40% respectively.

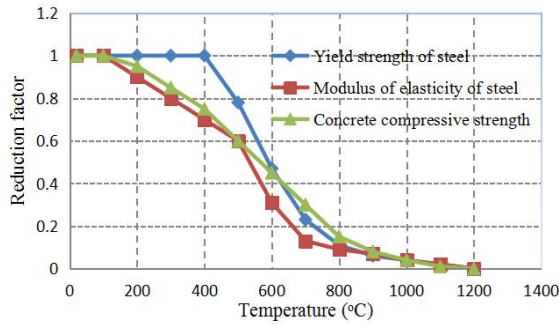
(b)

The cross sectional temperatures generated from thermal analysis are used as input to the strength analysis (i.e. generation of moment-curvature relationship and axial force-moment interaction diagram). In the strength analysis a finite element model was developed using XTRACT software as shown in **Figure 8a**^[14]. In the analysis it is assumed that plane sections before bending remain plane after bending and there is no bond-slip between steel reinforcement and concrete. The fire unaffected concrete compressive strength of 17 MPa which is obtained from material tests was used as initial value. The initial value of reinforcement bars yield strength was taken equal to 420 MPa. As the fire duration

increase the temperature will increase inside the column cross section causing reduction in the compressive strength of each concrete layer of the XTRACT model and also cause a reduction in the reinforcement bars stress-strain relationship. The reduction in material properties of concrete and reinforcement steel due to elevated temperatures was taken into account using reduction factors proposed by the Eurocode (see **Figure 8b**)^[4]. The proposed reduction factors are in good agreement with the experimental material tests results. This can be shown from the results in **Figure 7** and **Figure 8b** as follows: it is shown from **Figure 7** that at 120 min fire duration and at a depth of 100 mm from the face of the column, the concrete temperature was equal to 300°C; and at this temperature according to **Figure 8b** the reduction factor of concrete strength is about 0.8; that is the concrete strength becomes ($17 \times 0.8 = 13.8$ MPa) and this value are in good agreement with the experimental results given in **Table 1** and **Table 2**. The axial force-moment capacity diagrams and moment-curvature curves for the column at various time durations were obtained and presented in **Figure 9** and **Figure 10** respectively. From the Figureures it is clearly that both moment and axial load carrying capacities of the column decreases with increasing time of fire exposure. This is due to the deterioration in the material strength and stiffness as a result of increased temperatures in concrete and steel. Furthermore analysis results shows that up to 60 min of fire duration the column do not lose considerable amount of its strength, however at 120 min fire duration it will lose about 35 percent of its axial load and moment carrying capacities.

Figure 8; a) XTRACT FE model ,b) Strength reduction factor according to Euro code^[4].

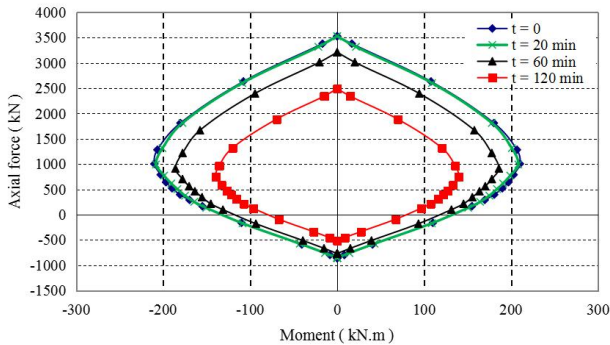
Figure 9; Axial force –moment interaction diagrams at various times for the RC column under fire exposure.

4. Strength capacity analysis results shows that up to 60 min of fire duration the column do not lose considerable amount of its strength, however at 120 min fire duration it will lose about 35 percent of its axial load and moment carrying capacities.
